MV Pasha Bulker Grounded in Newcastle

The MV *Pasha Bulker* is a Panamax bulk carrier of 76,741 metric tons deadweight (DWT) operated by the Lauritzen Bulkers Shipping company and owned by Japanese Disponent Owners. While waiting in the open ocean outside the harbour to load coal the *Pasha Bulker* ran aground during a major storm on 8 June 2007 on Nobbys Beach in Newcastle. It was refloated and moved to a safe location offshore on 2 July 2007 at 9:48 pm before being towed to Japan for major repairs on 26 July 2007.

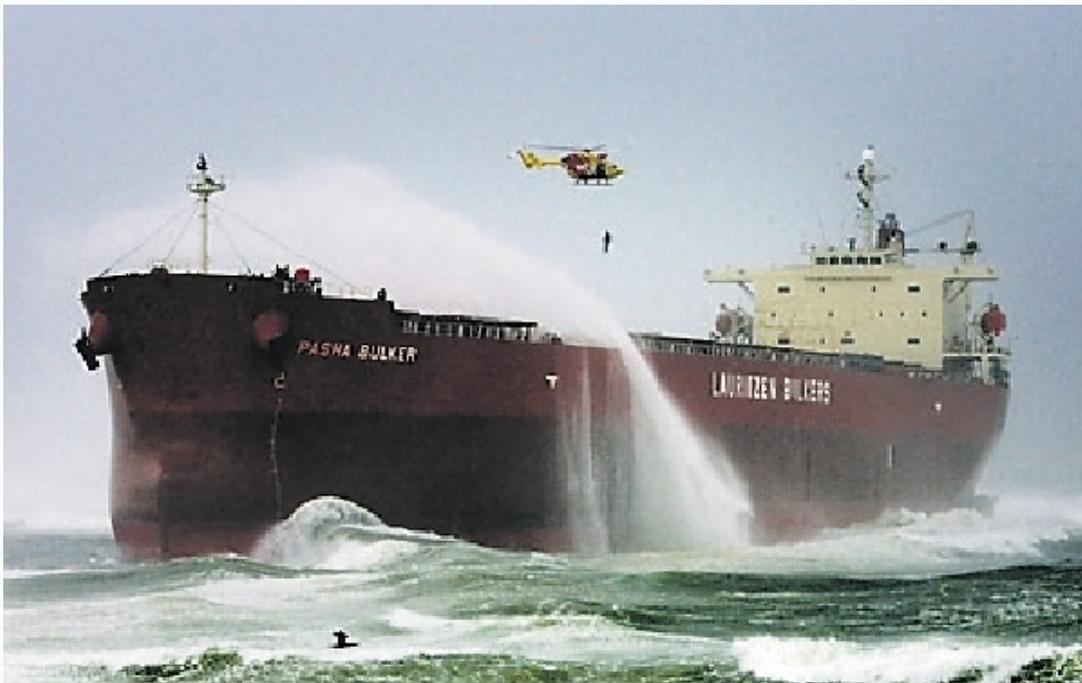
A rescue helicopter operating above the beached ship

After the *Pasha Bulker* ran aground the 22 Filipino and Korean crew members aboard were successfully rescued by the Westpac Rescue helicopter service from the vessel, however it remained grounded about 30 m from the shore at the popular Nobbys Beach. The ship was empty of any cargo at the time, awaiting to load 58,000 tonnes of coal from Newcastle Port. However, it contained around 700 tonnes of fuel oil, 38 tonnes of diesel and 40 tonnes of lube oil, which if released could have caused a major ecological disaster.

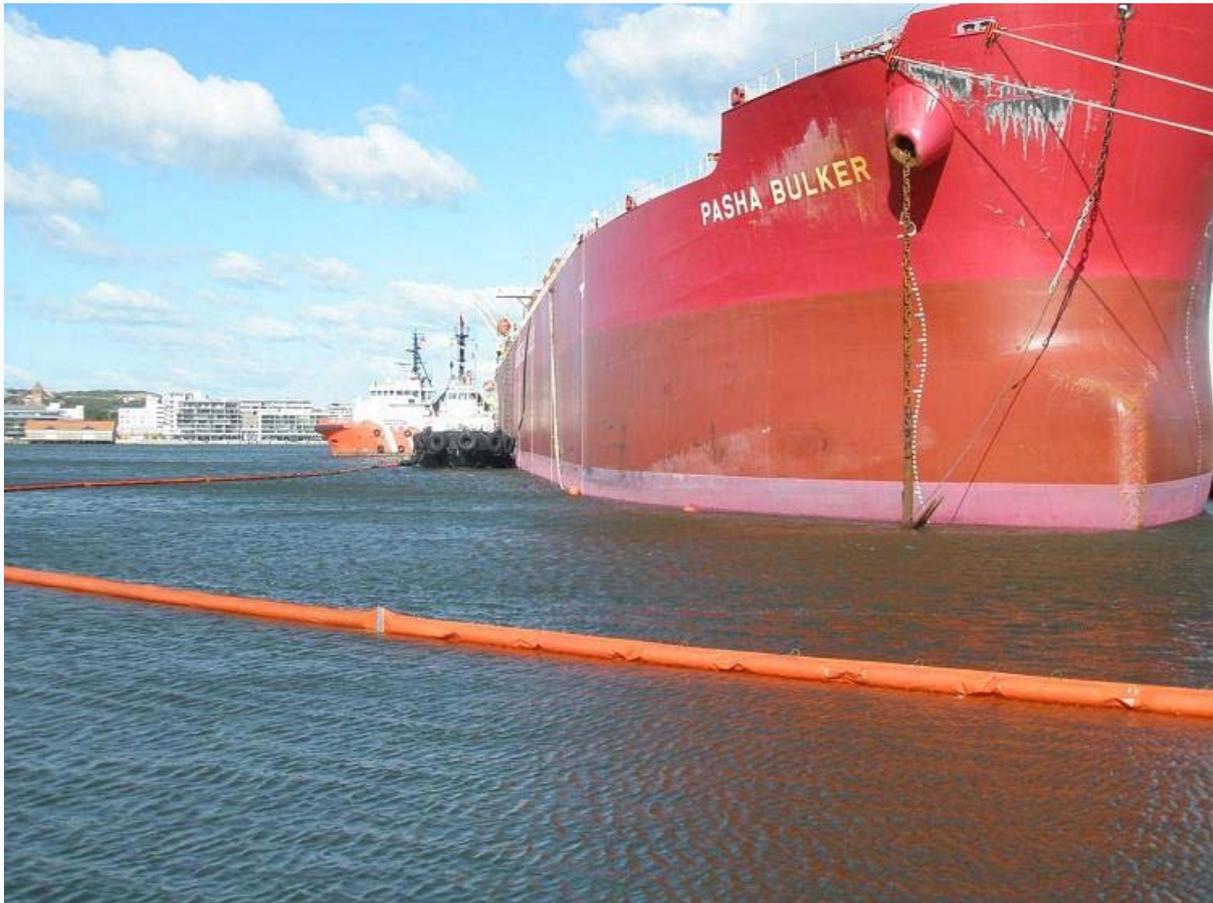
The damaged Pasha Bulker in Newcastle Harbour

In addition to large creases that were visible on both sides of the outer hull while the ship was beached, propeller and rudder damage became evident during the operation to remove the ship from the beach. Assessment by divers while the ship was being held offshore determined that one of the ballast tanks was flooded. Minor repairs to the *Pasha Bulker* were conducted in Newcastle harbour before the ship was towed by the Japanese supertug *Kyo Maru* for major repairs in Japan.

After the ship was refloated, questions as to who would pay for the recovery of the ship were raised. On 4 July 2007 it was announced that the Japanese owners had promised to pay for the total cost of the salvage in accordance with international conventions. The ship was towed into Newcastle harbour where minor repairs were carried out while a decision on where major repairs would be completed was made. Salvage costs of AU\$1.8 million were finally paid in July 2008.

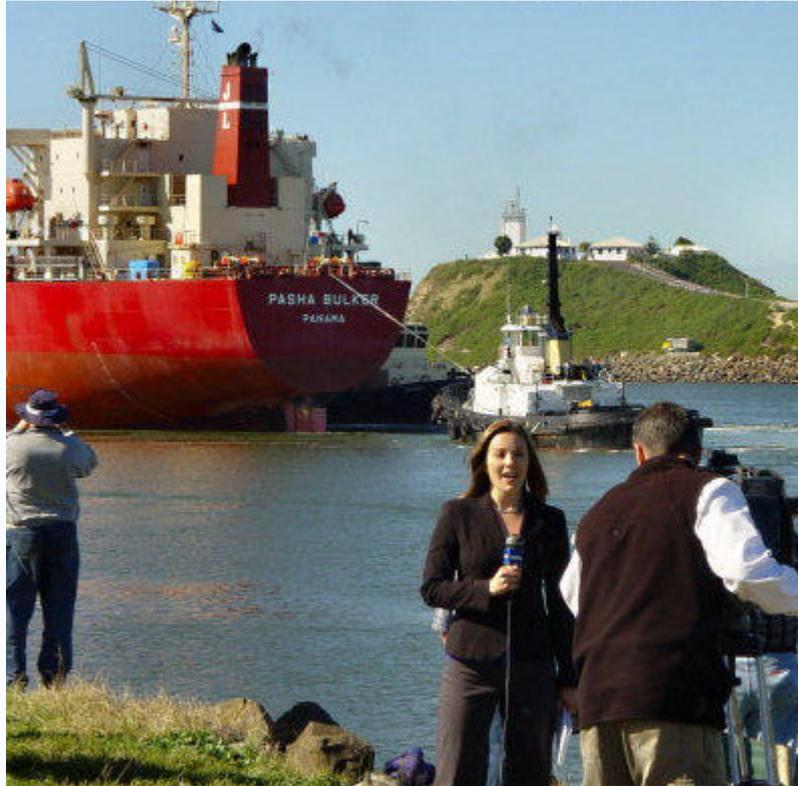
NBN News reports as the Pasha Bulker leaves Newcastle Harbour

The *Pasha Bulker* left the port of Newcastle on 26 July 2007. Four kilometres out to sea the Japanese salvage tug *Koyo Maru* connected lines to the *Pasha Bulker* for it to be towed back to Japan. Metal beams could be seen reinforcing the buckled hull, as these were part of the temporary repair solution affixed at Newcastle.

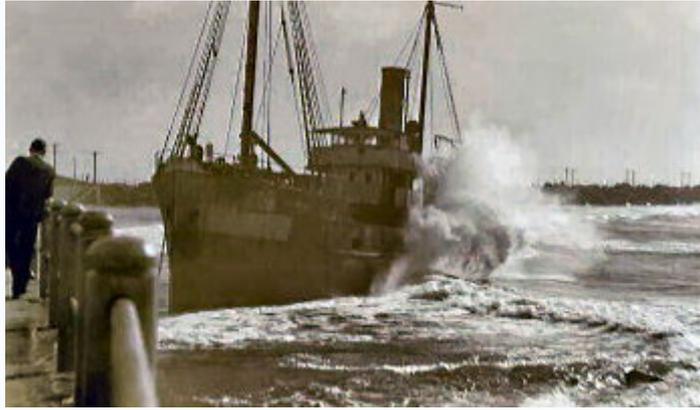
1940 – Maianbar runs aground on Nobby's Beach

However, it is not the first ship to run aground in the area. In 1940 the TSS *Maianbar*, a 493 ton steamship, broke its towline while en route to Sydney and drifted ashore near where the *Pasha Bulker* was beached. It was unable to be re-floated and was dismantled on-site. The *Pasha Bulker* beaching has also drawn parallels to the 1974 beaching of the *Sygn* on Stockton beach, some eight kilometres further north,.
